Improved RotoSense™ for Rolling Stock: Locomotives and Cars

Abstract— This paper describes work related to improving an accelerometer-based sensor, RotoSense™, used for monitoring rolling stock: the locomotives and cars used in trains. At the 2016 MFPT conference, the authors presented a paper, “Accurate Vibration and Speed Measurement on Rotating Shafts using MEMS and IoT Single Wireless Triaxial Sensor,” That sensor was capable of measuring shaft speeds of up to 5500 RPM: two example applications were described: (1) a helicopter gearbox, and (2) conditioning monitoring of a railroad track. This paper describes subsequent improvements to that sensor, in terms of ruggedizing and signal quality, to meet requirements of a manufacturer of rolling stock. The sensor described in the previous paper was the first (and only known) to survive, intact, three days of testing at the National Test Track Center in Pueblo, Colorado, including a 10-hour, non-stop, 400-mile test run. Even so, a manufacturer of rolling stock wanted more ruggedizing and better signal quality. The rationale, the methods, and the results of those improvements are presented in the paper.

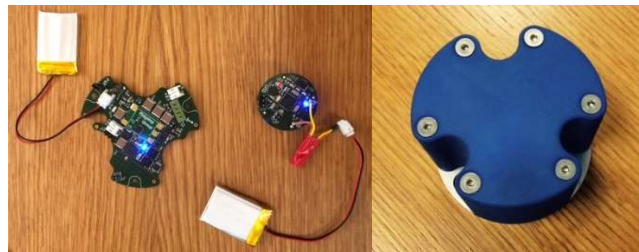
Figure 5. Boards with batteries and housing assembly

Wheel Hubs of Rolling Stock—A second example is the physical adaptation of the sensor for mounting on wheel hubs of the shafts of the trucks of train locomotives and cars (see Figure 5). This version of the MEMS sensor was designed and developed to prove feasibility for using such sensors to locate and identify anomalies related to railroad tracks.

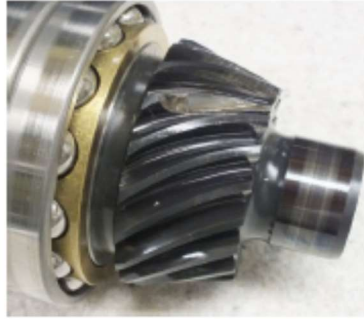
Figure 8. Failed gear – fractured tooth.

The sensors performed well, lasted the entire test, and all MEMS accelerometers gave an indication of failure at the end of the test. The MEMS systems performed as well, if not better than, the existing stationary accelerometers mounted on the gear box housing with regards to gear tooth fault detection (Figure 8).

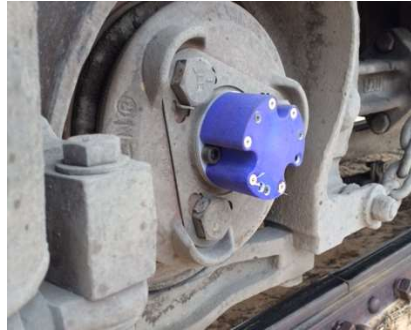
Figure 10: MEMS sensor mounted on a wheel hub

MEMS Configuration and Test Setup—The configuration for train applications includes a MEMS sensor, supporting firmware and software to support collecting, wireless transmitting of data to a gateway, and saving data in binary files. The assemblies are mounted to the wheel hubs to rotate with the axle so any anomalies in the wheels or track can be detected. The MEMS is configured as a three-axis accelerometer with 57mV/g sensitivity with a 161 Hz sampling

rate: sensor was mounted concentrically on each end of a freight car axle and also on a locomotive axle of a train (see Figure 10).

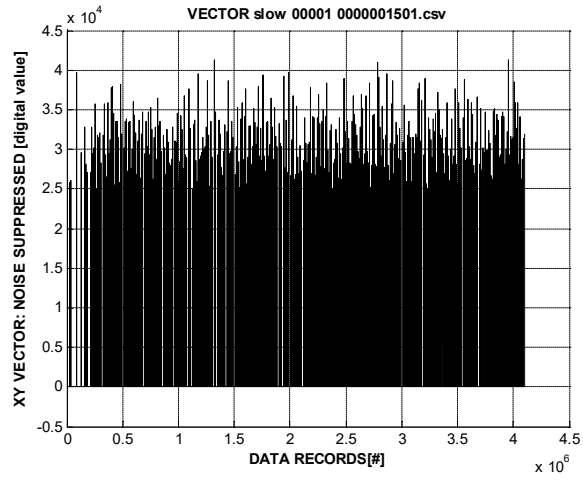
Figure 14. Raw data, xy-plane

Data Analysis—Data analysis was hampered by the loss of Global Positioning Data (GPS) caused by a broken antenna. Consequently, raw data (see Figure 14) was analyzed by binning the data in terms of magnitude (xy-plane, the z-plane, and both planes) and relative laps (see Figure 15), examining the peaks, and comparing those peaks to features of the test track: pattern matching. We successfully proved that, even without GPS, we were able to synchronize the data to the start of the test track and then locate those features that could be located: as seen indicated in Figure 16 and Table 3.

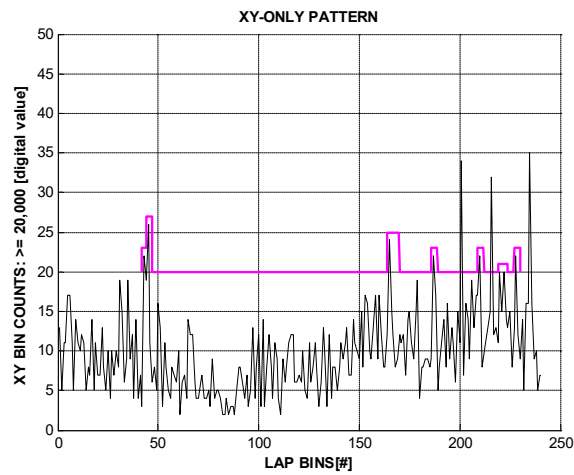
Figure 15. Binned data, xy-plane, by lap-bin number

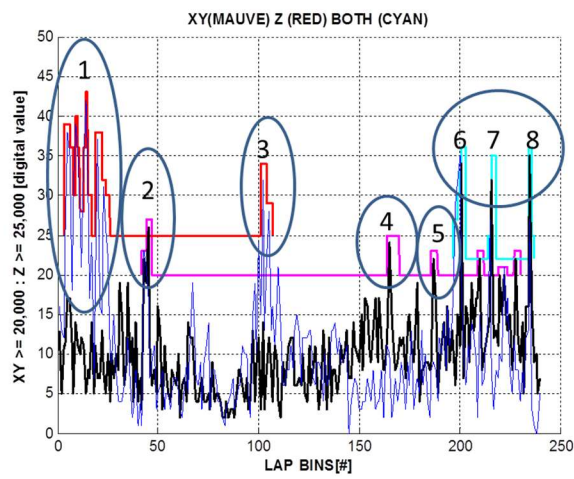
Figure 16. Data and identified features

Track Sections	Feature Sections	TT ID	Track Feature	Detection Evaluation	
				XY-vector	Z-vector
1 – 3		S1	Lubricator	ND	ND
4 – 5		S2			
6 – 62	5-26	S3	Repair/overlay welds		Yes (1)
	30-40	S3	Concrete bridge	maybe	maybe
	42-46	S3	Concrete bridge	maybe	Yes (2)
63 – 66		S4	Steel bridges	ND	ND
67 – 69		S5	Bridge deflection	ND	ND
70 – 73		S6	Steel bridges	ND	ND
74 – 92		S7	Rail performance	ND	ND
93 – 97		S8	Fiber optic cable	ND	ND
98 – 108		S9	405 turnout/frog		Yes (3)
109 – 117		S23	405 turnout/frog		Yes (3)
118 – 125		S24	Lubricator	ND	ND
126 – 163		S25	TPO, Tie and fastener, performance	Yes (4)	
164 – 170		S26			
171 – 175		S27	Lubricator	ND	ND
176 – 180		S28	Turn out, steering switch, foundation	Yes (5)	
181 – 193		S29	LTM Tests	ND	ND
194 – 198		S30			
199 – 208		S31	FRA: Rail-seat deterioration, Thermite welds	Yes (6)	Yes (6)
209 – 212		S32			
213 – 225		S33	Crib ties	Yes (7)	Yes (7)
226 – 229		S34			
230 – 240		S35	407 turnout	Yes (8)	Yes (8)
